RAPID Applications for Large-Scale Experiments

2020 UCSD/RAPID Joint
Workshop

Example Project 1: Reconnaissance of Large Volume Low Rise Buildings

Example Project 2: E-Defense Deployment for Light Frame Timber Building Tests

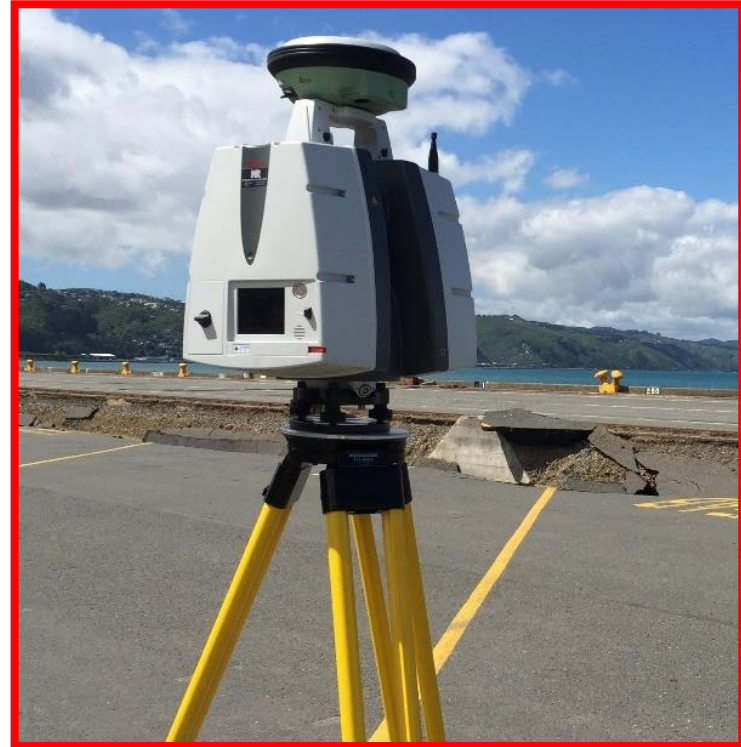
The Leica P50 is RAPID's highest accuracy and precision scanner (and the best currently available). It is recommended for applications such as crack detection/quantification

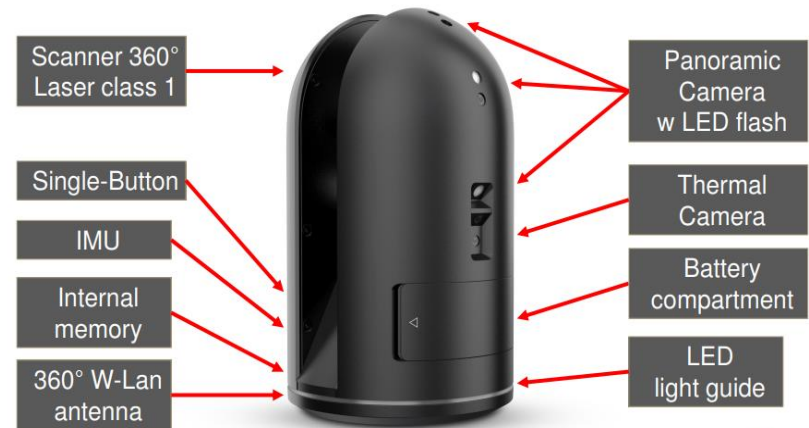
Leica BLK360

- ◆ Distance measurement system: High speed time of flight enhanced by WFD technology.
- ◆ Wavelength: 830 nm
- ◆ Field of view: 360° (horizontal) / 300° (vertical)
- ◆ Range*: min. 0.6 - up to 60 m
- ◆ Point measurement rate: up to 360,000 pts/sec
- ◆ Ranging accuracy*: 4mm @ 10m / 7mm @ 20m
- ◆ Measurement modes: 3 user selectable resolution settings

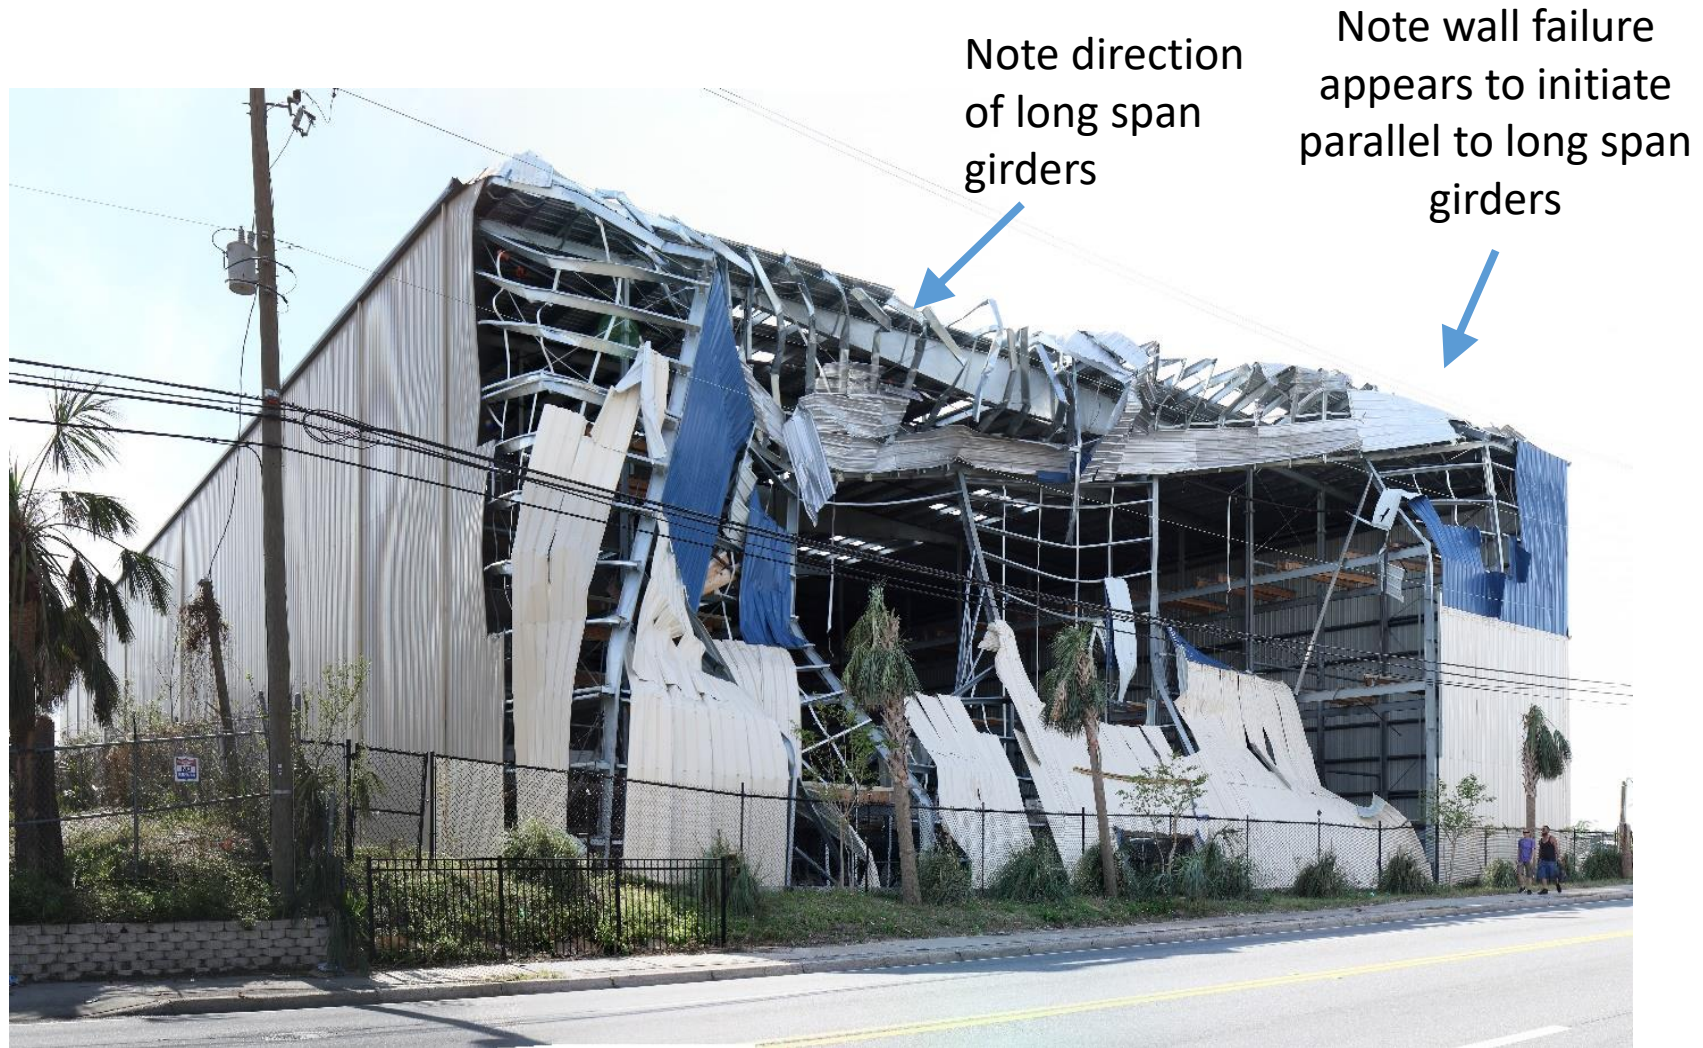
Watson Landings Marina

Building Damage Examples

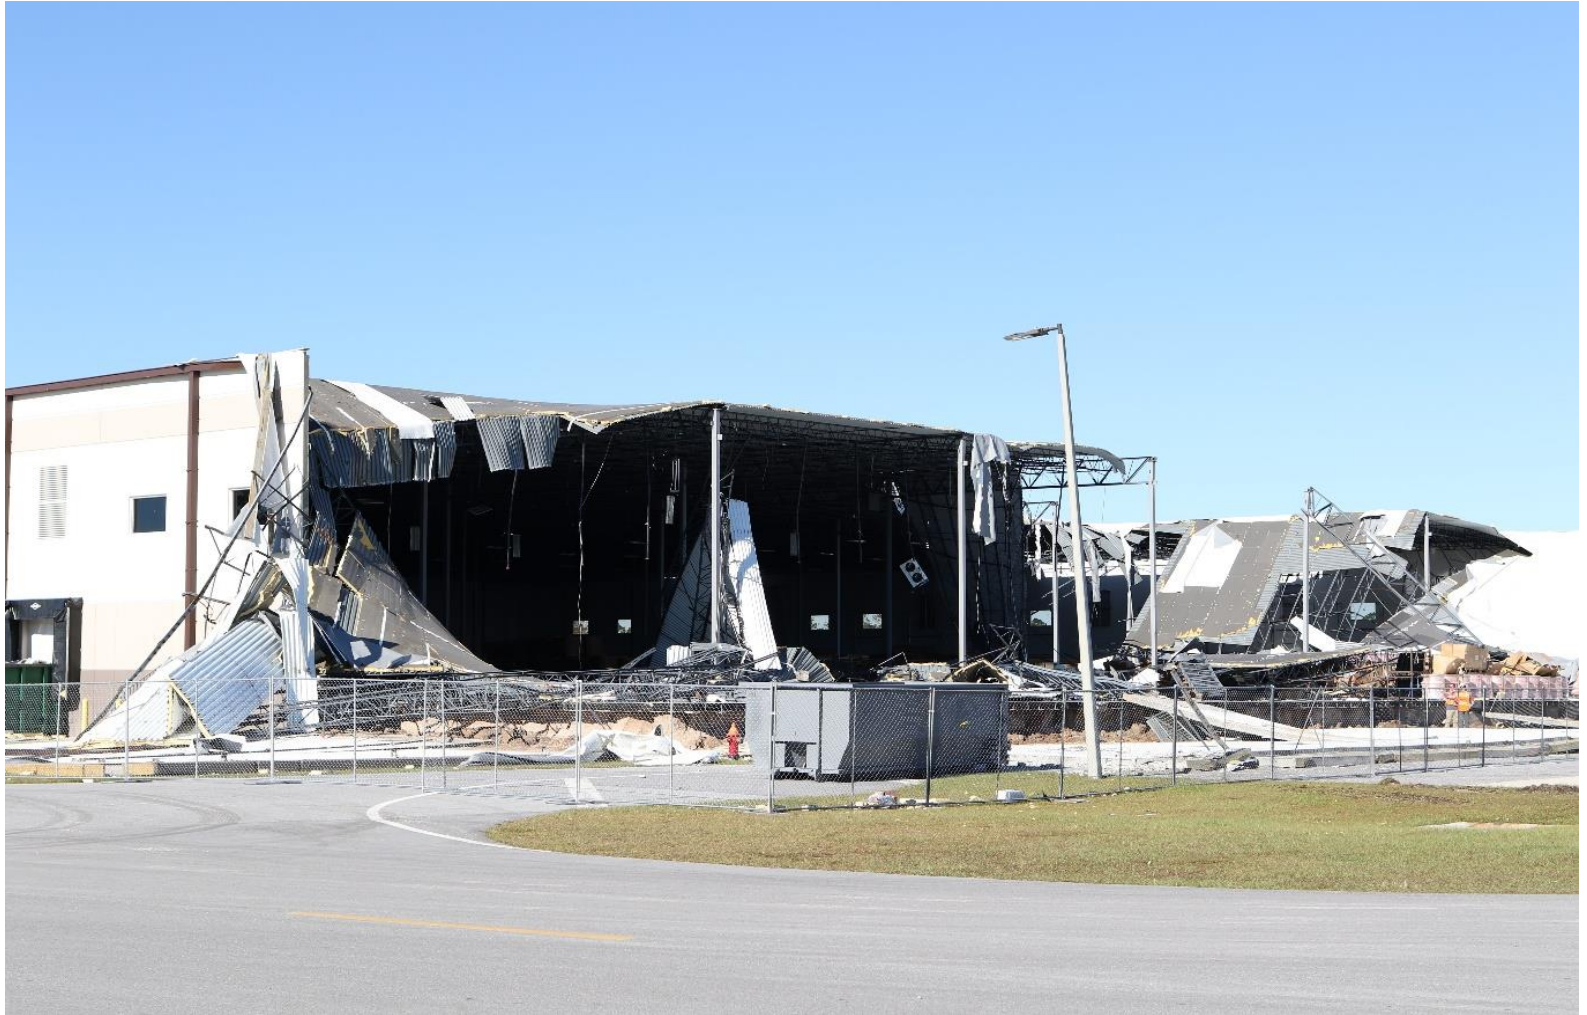
Intermodal Distribution Center

Building Damage Examples

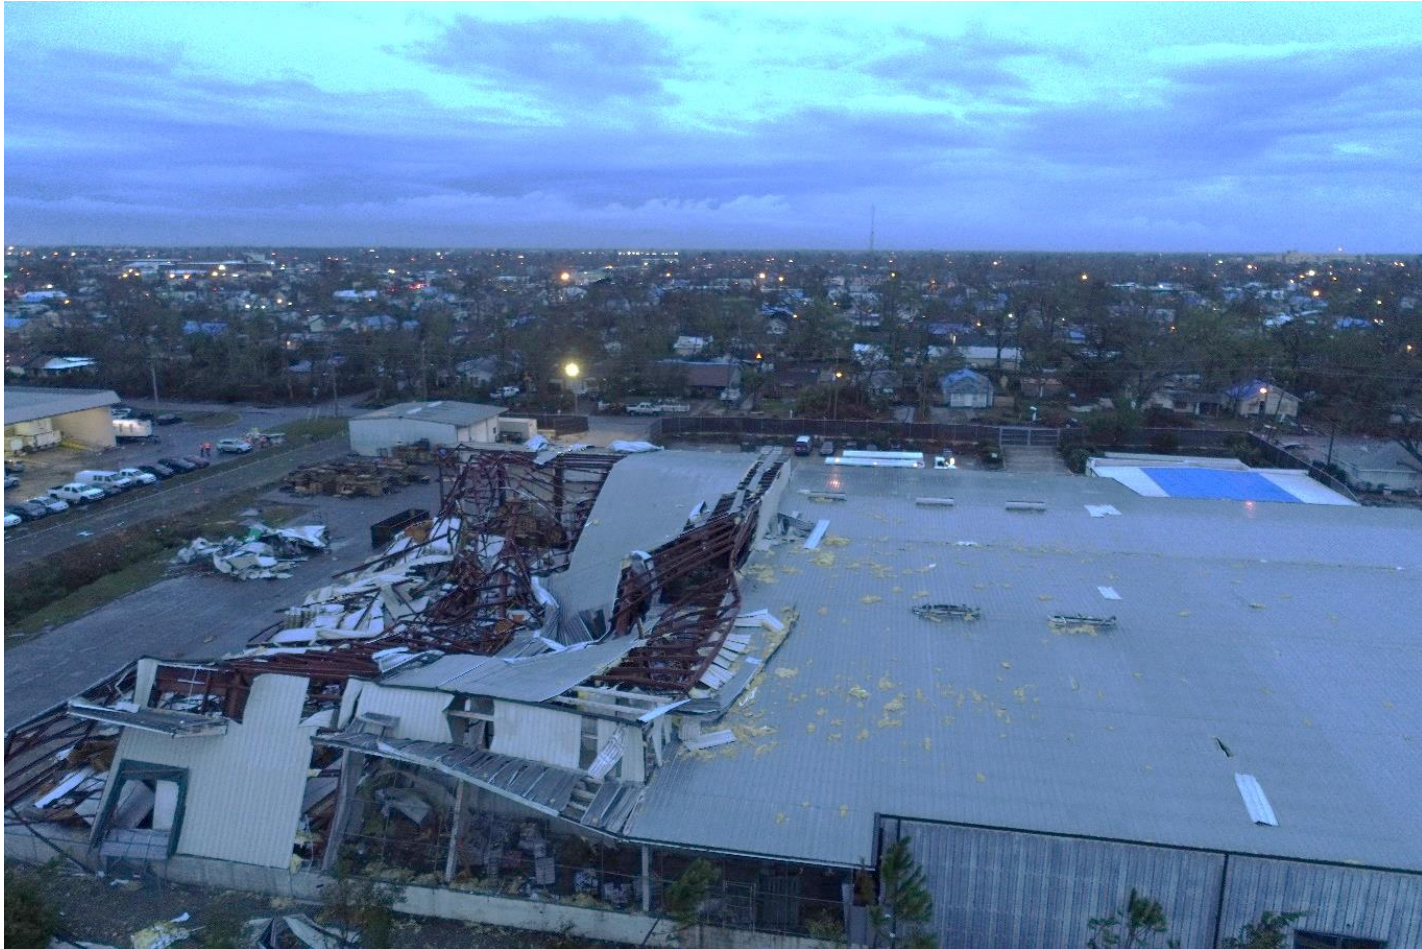
Miller Distributing

Building Damage Examples

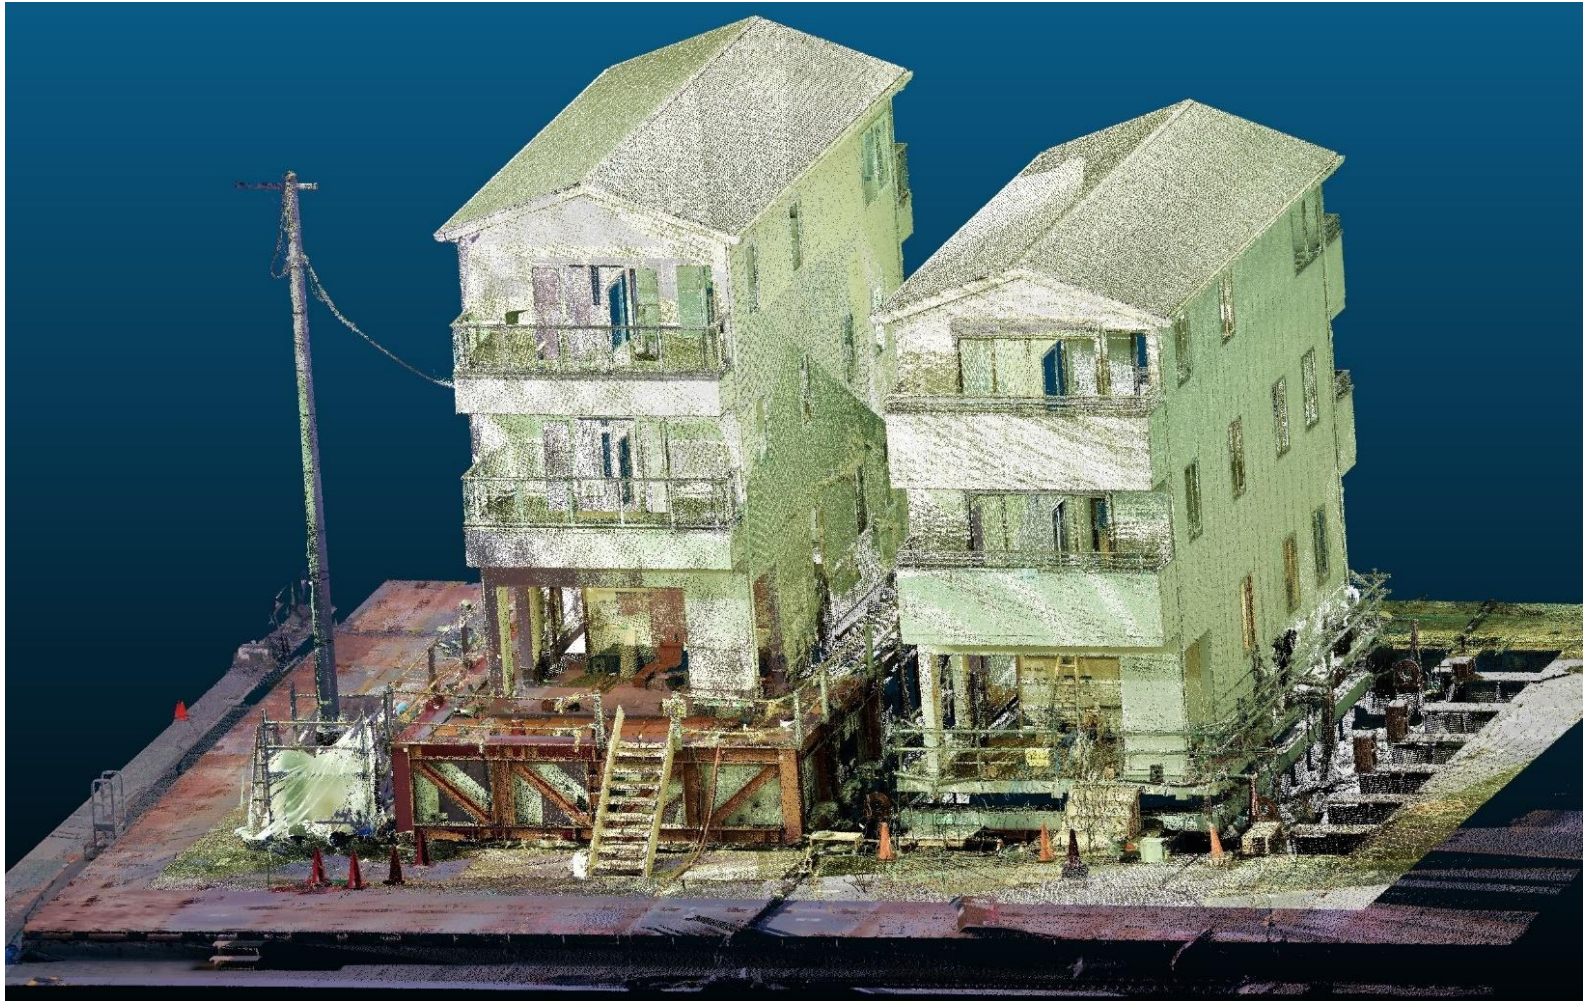
Data products: sub-cm level accuracy point clouds of the two buildings before testing and after each of 6 ground motions

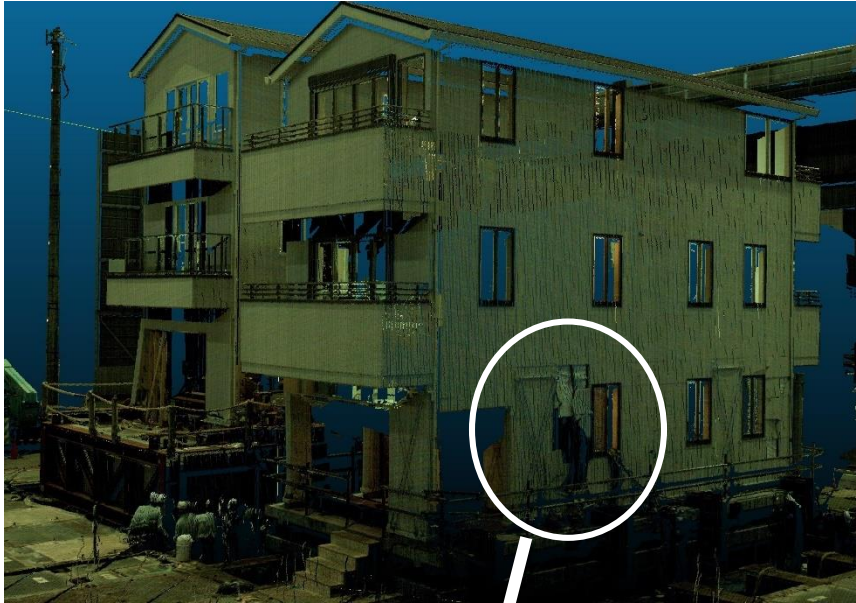
Damage progression to nonstructural components measured to sub-cm accuracy for the entirety of the two buildings

Discovered residual building torsion not observed in the conventional instrumentation

Quantified evolution of nonstructural damage

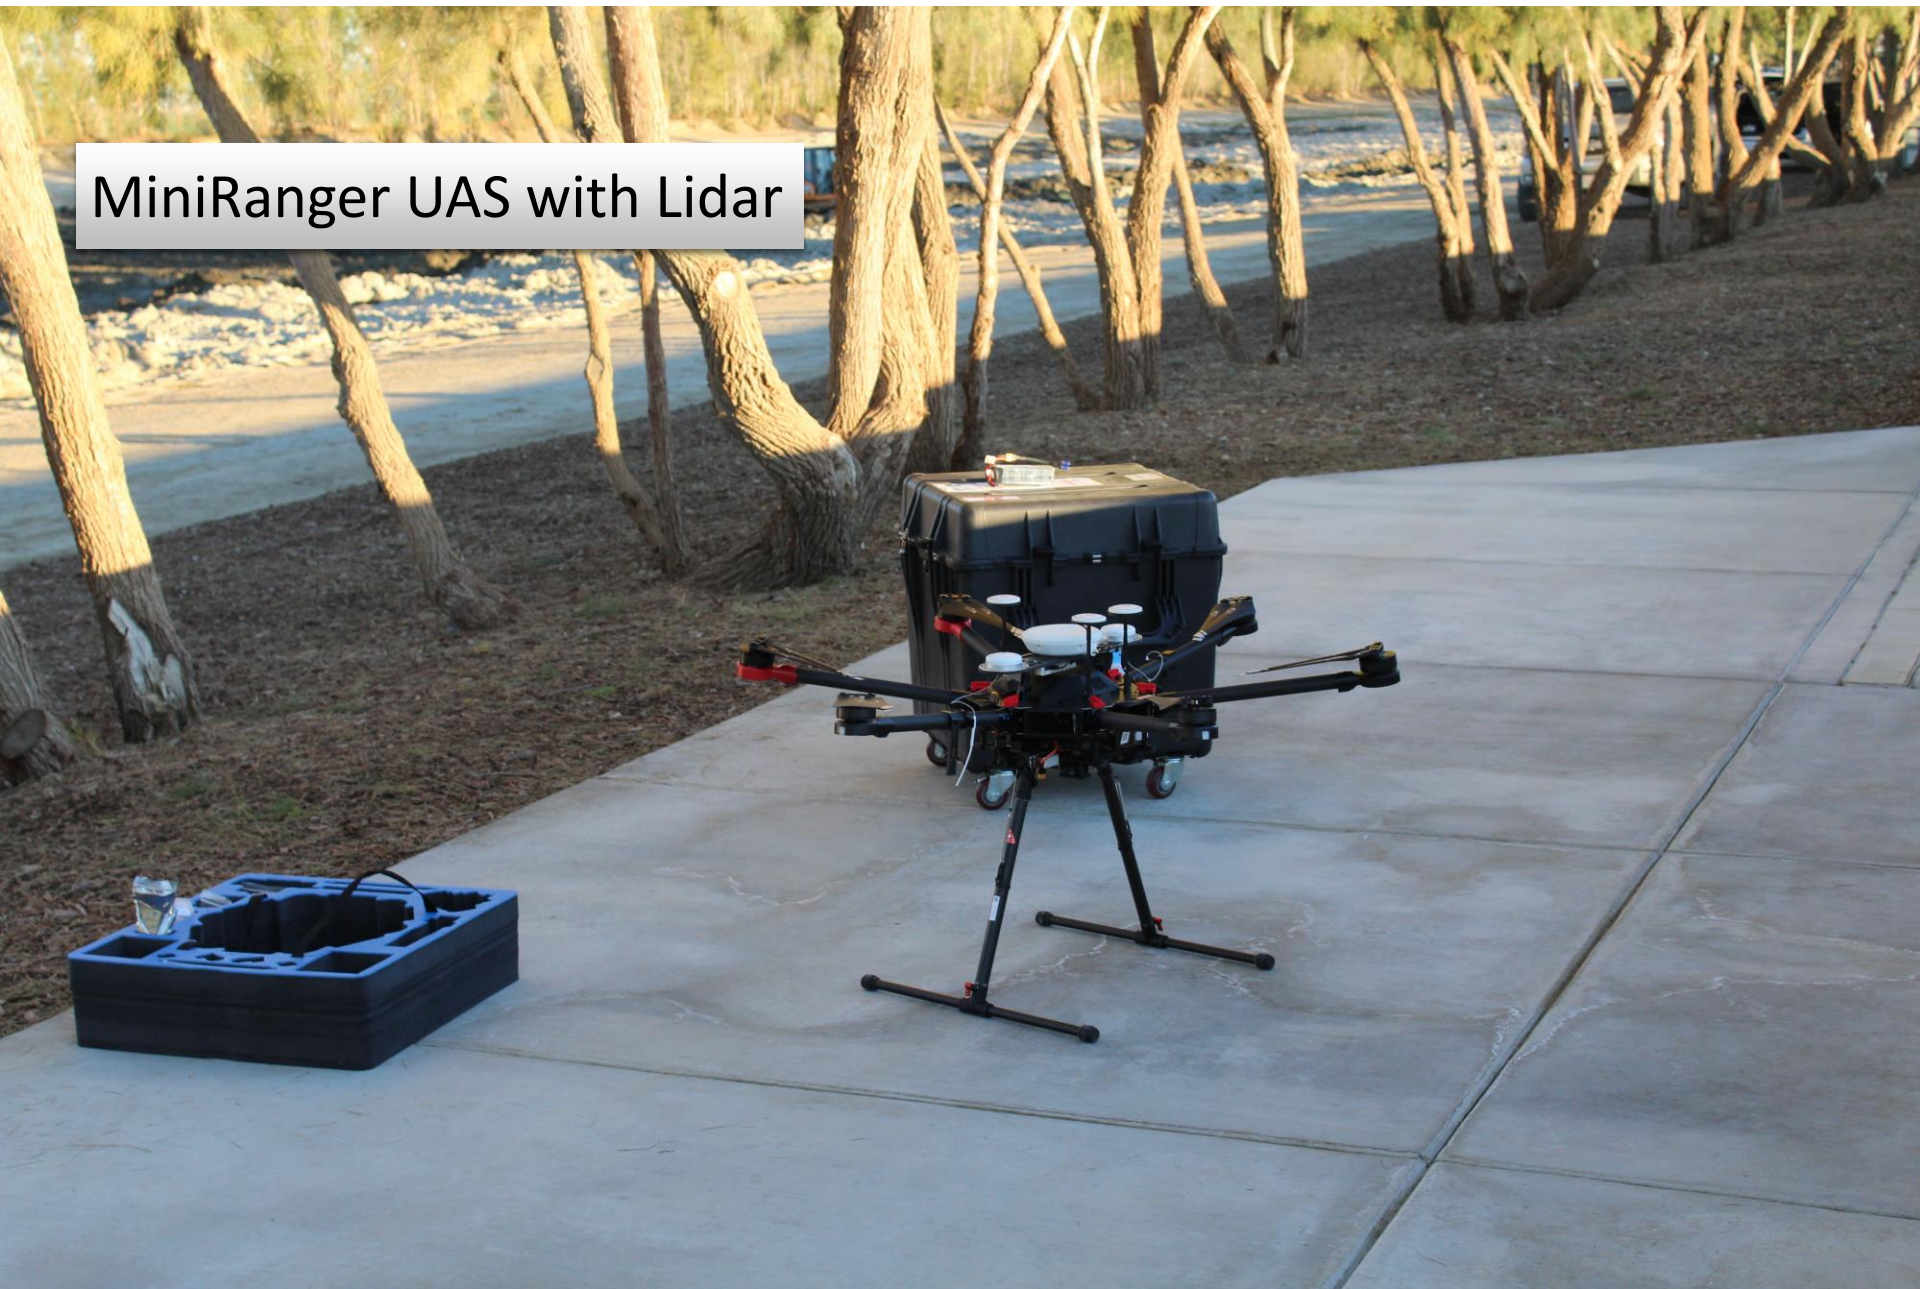
MiniRanger UAS with Lidar

drone w/ lidar

lidar on rig
